Managing the Arroyo Seco for Flood Prevention, Erosion Control, Waterway and Habitat Restoration

L. A. Sanchez, C. Wang, and J. R. Laurant

This article was submitted to :
World Water and Environmental Resources Congress 2003
Philadelphia, PA, June 23-26, 2003

February 6, 2003

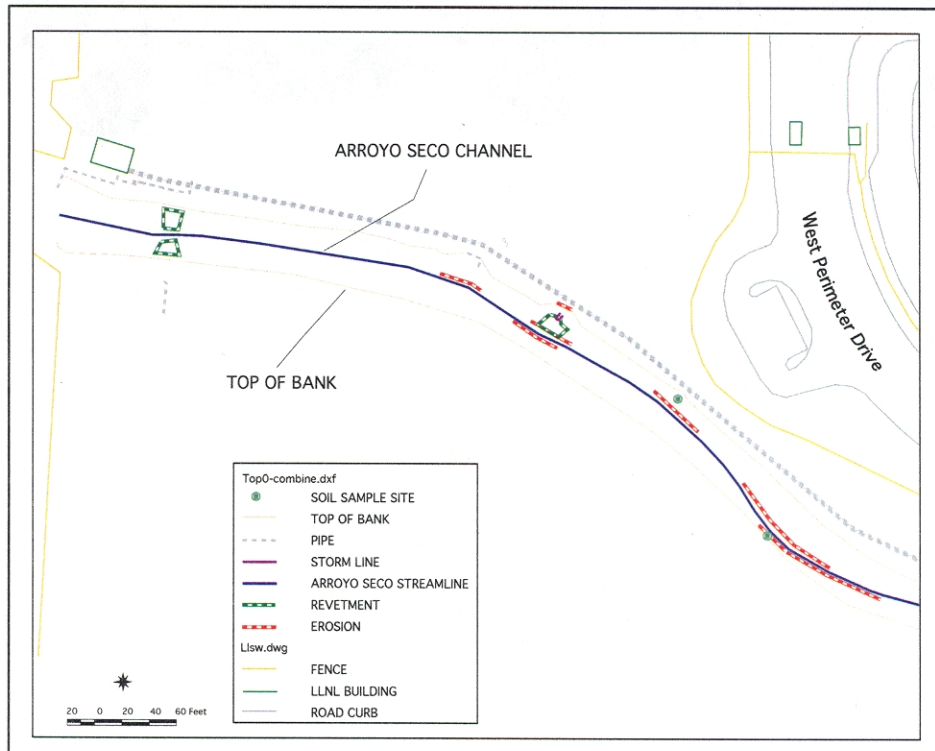
Figure 1. Arroyo Seco Project Area - West

The 1,800-foot reach of the Arroyo Seco on LLNL is a relatively small section of the approximate 10-mile reach of the main branch of the Arroyo Seco creek upstream from LLNL. Figures 1 and 2 show the 1,300-foot project area of the Arroyo Seco on LLNL, west of where one of the site's main access roads, West Perimeter Drive, crosses the arroyo. The average channel bed slopes of the 1,300-foot length of the Arroyo Seco depicted in Figures 1 and 2 are 0.013 and 0.016, respectively. Bank heights are typically 15 to 20 feet high with bank slopes that range from 1H (horizontal):2V (vertical) to vertical; the top-of-bank widths in this portion of the Arroyo Seco range from 30 to 50 feet.

The 1,300-foot project reach also includes the majority of LLNL's historic revetment installations and current erosion problem areas, also depicted in Figures 1 and 2. In contrast, Figure 3 is illustrative of the remaining upstream 500-foot length of the Arroyo Seco on LLNL, east of West Perimeter Drive. This eastern reach is the most undisturbed portion of the Arroyo Seco on LLNL.

Development of LLNL has also increased the area of impervious surface contributing flow to the Arroyo Seco. Overbank flows from adjacent roads and parking areas are eroding the top-of-bank area of unprotected storm drain outfalls. Along approximately one third of the 1,300-foot length depicted in Figures 1 and 2, the

channel bed has incised some 3 to 5 feet, creating over-steepened and unstable banks from toe undermining and some shallow geotechnical slump failures.

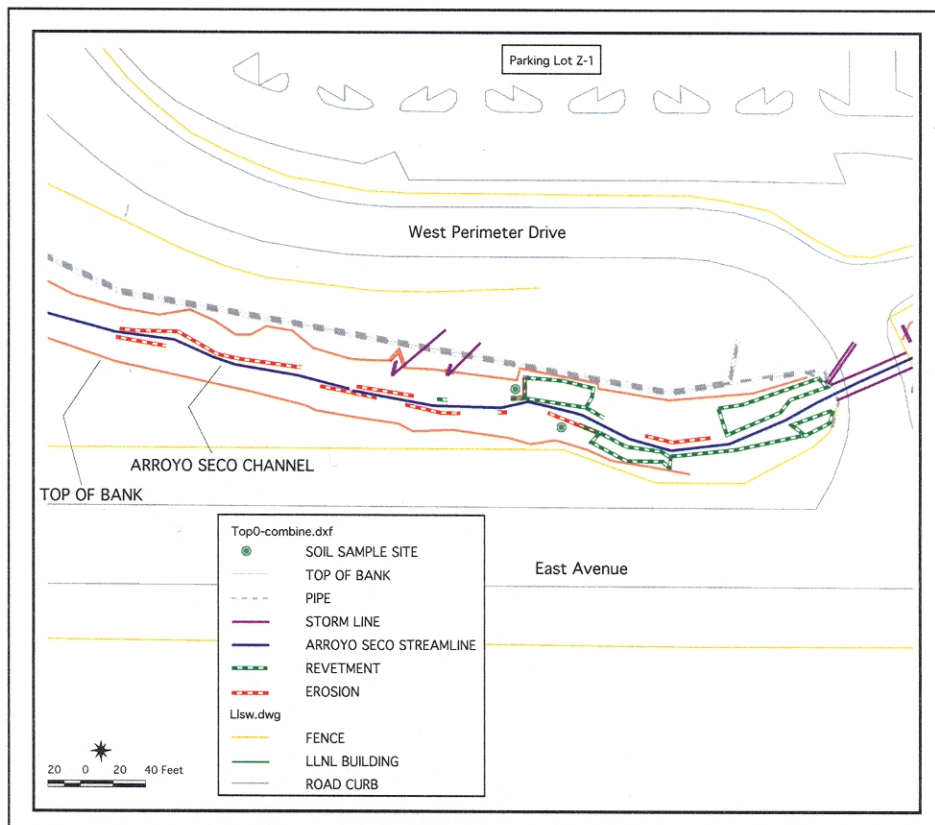
Figure 2. Arroyo Seco Project Area - East

Locally severe bank erosion near the arroyo crossing at West Perimeter Drive (Figure 2) required LLNL to construct emergency repairs to protect East Avenue along the southern perimeter of the site. These repairs consisted of gabion baskets and steel sheet piling. However, flows deflected off the armoring contributed to erosion in the transition zones between the revetment and the creek bank. The picture in Figure 6 shows a typical transition zone between one of the gabion basket installations and the creek bank. Erosion control blankets were installed in some of these transitions zones but were ineffective at such steep slopes and bank erosion continued.
